# Back-to-front flipping of an anatomical implant 31 months after augmentation mammoplasty: a case report

**Introduction:** Augmentation mammoplasty is one of the most commonly performed surgical procedures by plastic surgeons. Back-to-front flipping of an implant after augmentation mammoplasty is a rare complication, occurring in 0–5% of cases. **Case report:** The authors report a patient who presented with back-to-front flipping of an anatomical implant 31 months after augmentation mammoplasty.

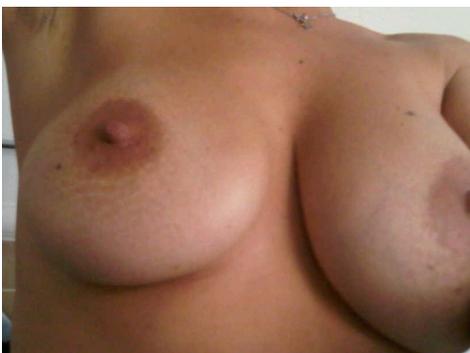
**Figure 3.** At 31 postoperative months, changes were observed in the shape of breast D, with nipple height asymmetries and anterior face alteration.

The implant was returned to its proper position through external manipulation. The patient was provided with guidance about the increased possibility of a second flipping, and she opted to not undergo a second surgical procedure.

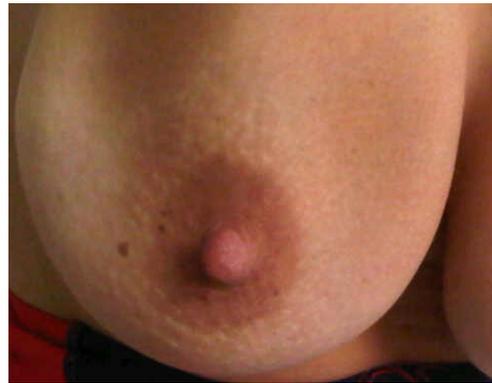
**Figure 4.** Details of breast D, with the patient leaning forward; a flattened aspect can be observed.

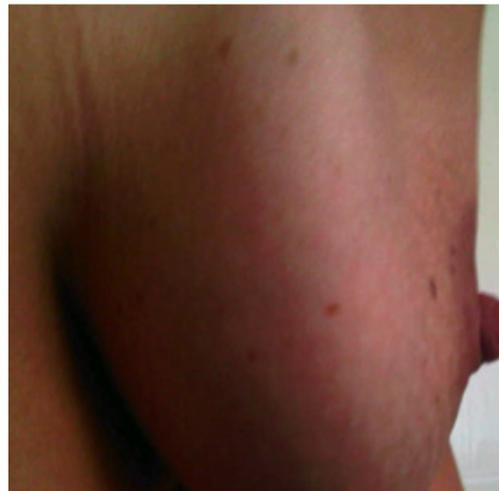
**Figure 5.** Profile with the anterior face alteration of breast D.

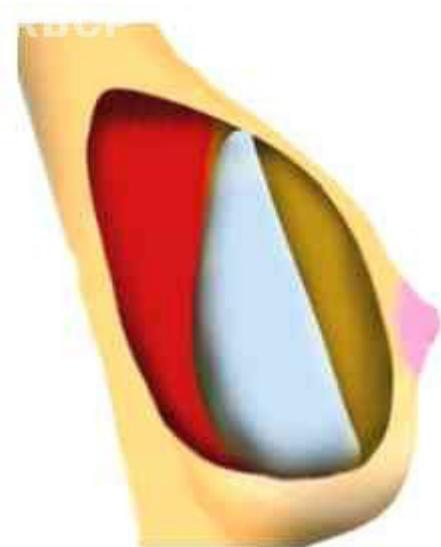
**Figure 6.** Schematic diagram of the back-to-front flipping of the anatomical implant, in a profile view.

Back-to-front flipping (as a pancake) is rare, reportedly accounting for 0–5%<sup>4–15</sup> of cases. Diagnosis is clinically performed through physical examination of the patient and observation of possible changes in breast shape, without the need for diagnostic examinations<sup>16</sup>.

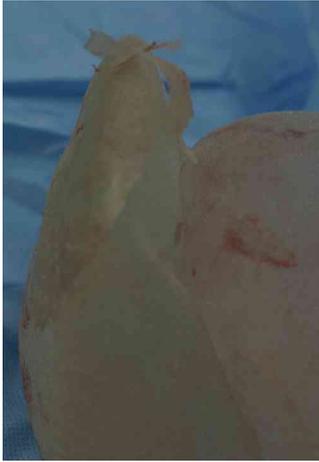
**Figure 7.** Capsule with more than one layer surrounding the implant.

For such prostheses, fasteners proved to be inefficient. Rendering a wrinkled surface with pores (texture) was also ineffective, as the body recovered the texture, smoothing it. In these cases, two capsules or a capsule with several layers, instead of a single capsule, surrounded the implant. In these capsules, fluid can accumulate (in the laminar liquid layer) and possibly trigger the implant rotation<sup>3,4</sup>.

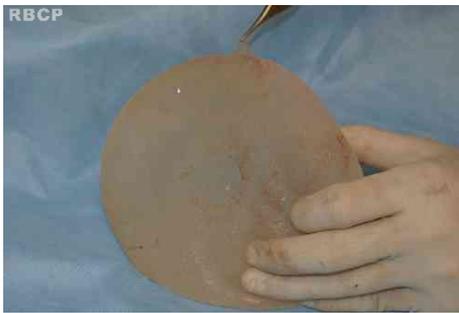
**Figure 8.** Example of a prosthesis with two capsules. The image depicts a capsule surrounding the implant and smoothing of the microtexture.
